WOOD DESTROYING PESTS AND ORGANISMS INSPECTION REPORT

Building No. 3322	Street Methilhaven Lane	City San Jose	ZIP 95121	Date of Inspection 09/01/2020	Number of Pages 8
----------------------	----------------------------	------------------	--------------	----------------------------------	----------------------

Report # : 7680

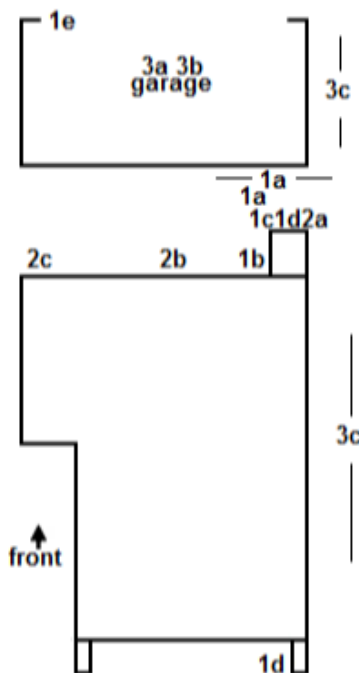
Diagram Not To Scale

FINDING: The exterior wood siding is fungus damaged, noted as 1A on the diagram.

FINDING: Fungus damage, noted as 1C on the diagram, was found to the water heater siding, framing and jambs.

FINDING: Evidence of drywood termites noted as 1D on the diagram. Location: Water heater closet and electrical box.

FINDING: Fungus damage, noted as 1E on the diagram, was found to the main garage door jamb.

FINDING: Gutter(s) or downspout(s) are missing, damaged or otherwise ineffectual and are noted as 2A on the diagram.

FINDING: Faulty grade level(s) noted as 2B on the diagram. This condition is conducive to infestation and infection.

RECOMMENDATION: Remove damaged siding only and replace with new siding in the damaged area. It is possible siding will not match perfectly. We will match as close as possible. We will primer paint only.

RECOMMENDATION: Remove and replace the damaged wood members. This company does not paint.

RECOMMENDATION: It is not feasible to fumigate this property, as it is a multi-unit complex. Therefore, we recommend a local treatment for drywood termites with registered termiticide. Local treatment is not intended to be an entire structure treatment method. If infestations of wood-destroying pests extend or exist beyond the area(s) of local treatment, they may not be exterminated.

RECOMMENDATION: Owner to contact appropriate tradesman to correct this condition per local building codes.

RECOMMENDATION: Raise foundation height at these areas per local building codes.
